Manhole Inspection Summary

Manhole # S21G__062MH

Location Address: **1719 BRUCE ST** Cross Street: **LEXINGTON ST**

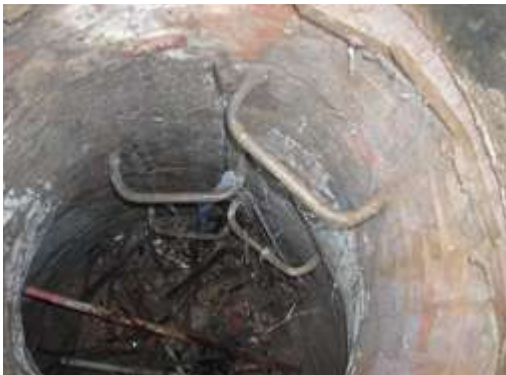
Defect 2

Steps Count: **4** Missing: **0** ☒ **Corroded**

CORRODED STEPS

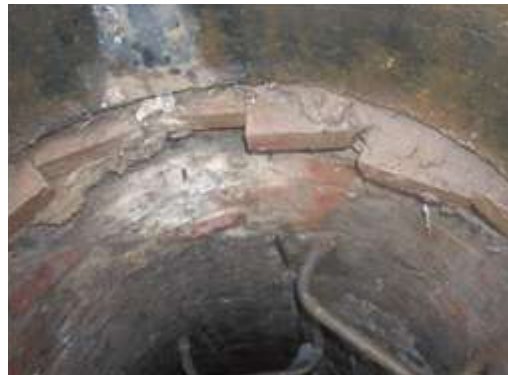
Defect 1

Frame Offset: **1** (in.) Condition: ☒ Sound ☐ Cracked ☐ Leaks

Chimney / Frame Adjustment ☒ Exists Material: **Brick** ☐ Parged Height: **1** (in.)
Condition: ☐ Sound ☐ Cracked ☐ Root Intrusion ☒ **Loose Brick** ☐ Deteriorated
Infiltration: ☐ None ☒ **Joint** ☐ Cracks ☐ Mortar ☐ Roots ☐ Wall

FRAME OFFSET, LOOSE CHIMNEY
BRICKS AND INFILTRATION OF THE
JOINT

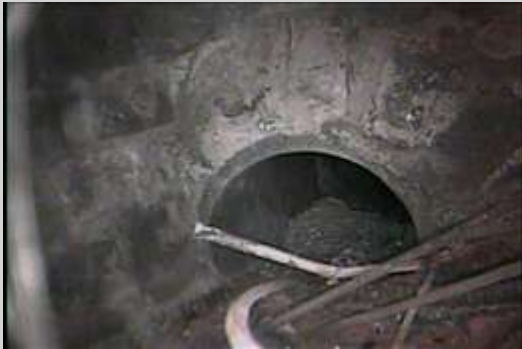
12 O'Clock Outflow

8 in. Circular Gravity Sewer
Pipe Out @ 12 O'Clock

Deposits: ☐ None ☐ Mud ☐ Sludge ☒ **Debris** ☐ Grease

Silt Depth: **2** (in.) Deposits Extent: **Light**
